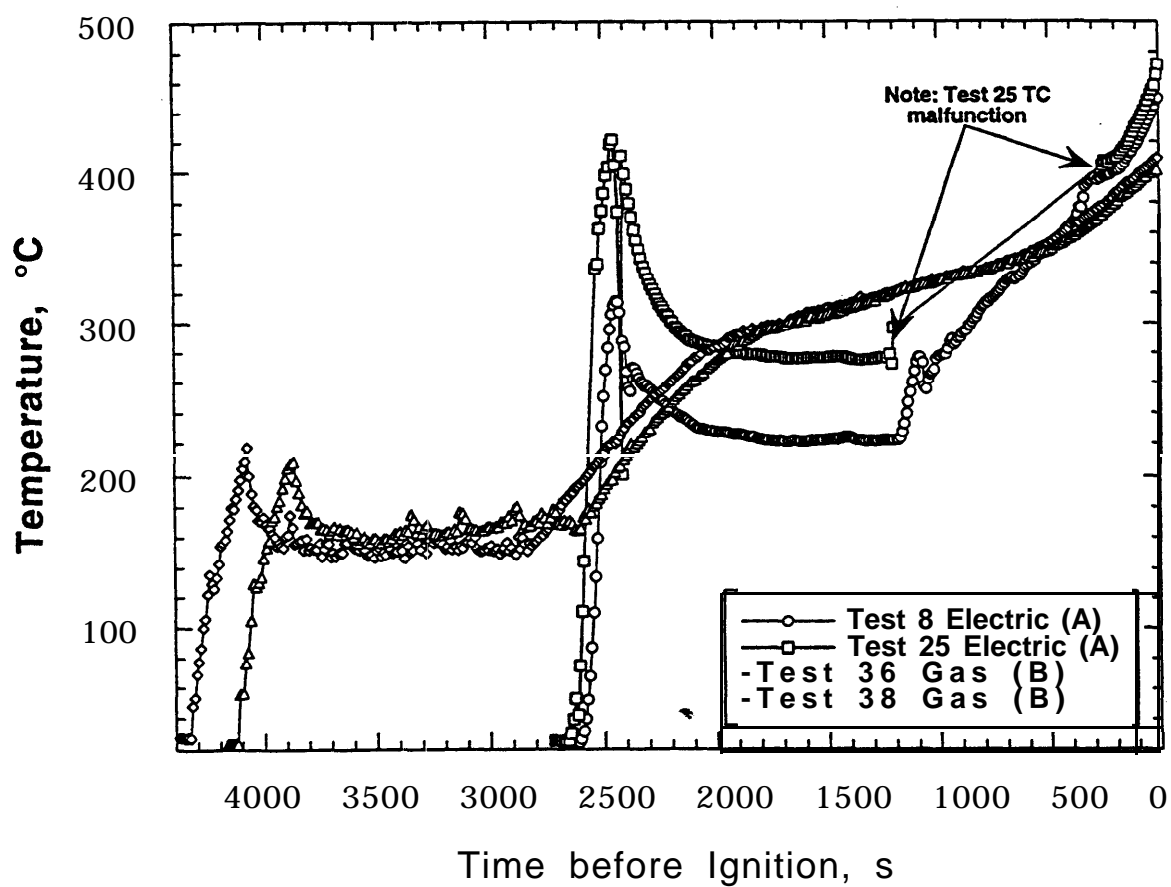
Figure 55. Pan-bottom temperature versus time before ignition for chicken in oil (normal→unattended) for the electric (A) and gas (B) ranges.

Figure 55 is a plot of the pan-bottom temperature versus time before ignition for the chicken and oil case that progressed from normal to unattended cooking for tests performed on both ranges. The temperatures during the normal-cooking period of the tests vary by 60 °C (140 °F) to 120 °C (250 °F). The electric-range temperatures varied between the two tests as well by about 60 °C (140 °F) during the normal period. The gas-range temperatures were very similar throughout the tests and nearly indistinguishable for the last 2000 s before ignition. For the last 300 s, the electric-range tests resulted in nearly identical temperature curves as well. The pan-bottom temperatures on the electric range reached maxima of 450 °C (840 °F) and 470 °C (880 °F). The pan-bottom temperatures on the gas range reached maxima of 400 °C (750 °F) and 410 °C (770 °F). Using absolute temperatures and comparing to the lower values from each pair of tests, these variations in pan-bottom temperature at ignition are 2.7% and 1.5% for electric and gas, respectively.

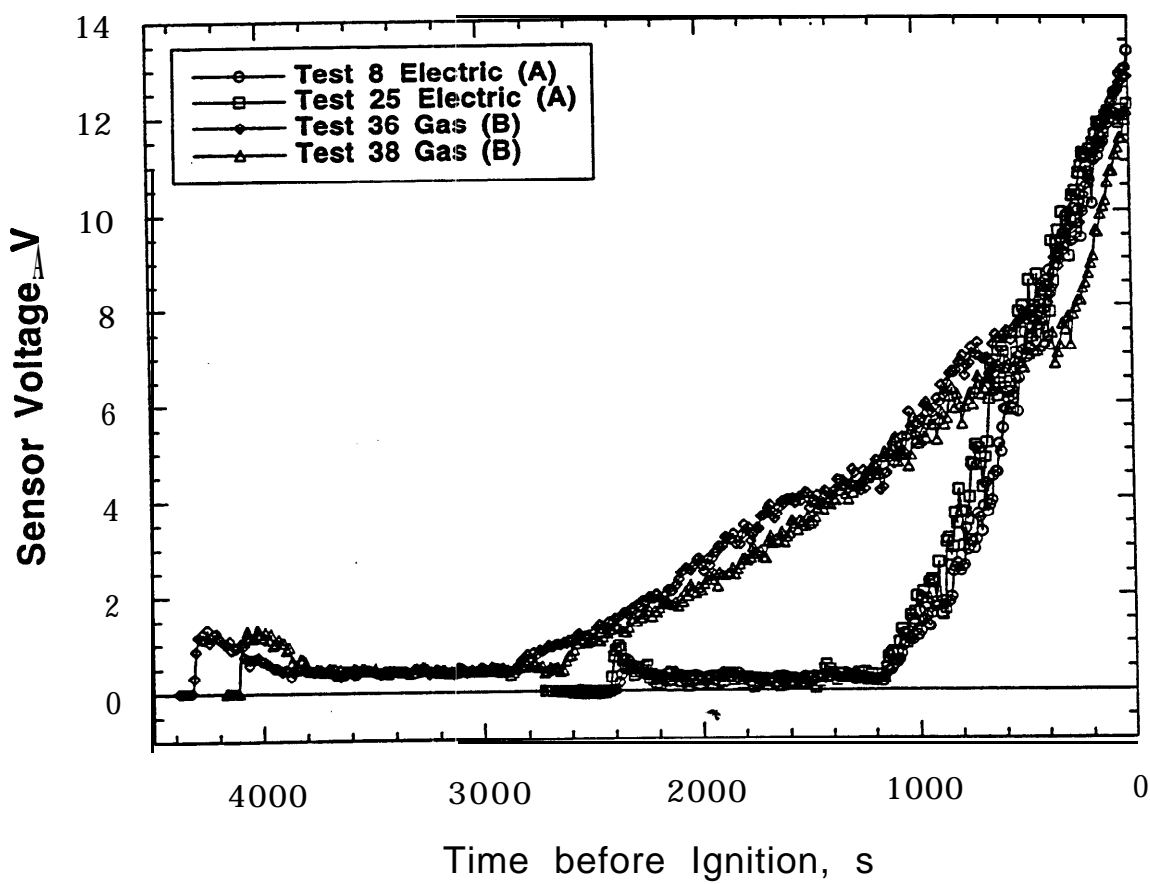
Figure 56. Site 9 general-alcohol sensor **response** versus time before ignition for chicken in oil (**normal**→**unattended**) for the electric (A) and gas (B) ranges.

Figure 56 is a plot of the Site 9 general-alcohol sensor response versus time before ignition for the same test on both ranges. Both of these tests show excellent reproducibility. The rate of increase of the signal during the unattended period of the tests on the electric range is about a factor of two greater than the rate for most of the unattended period for the tests on the gas range. The rate of increase for the gas-range tests **does** increase to match that of the **electric-range** tests in the last 300 s to 500 s before ignition. All of the tests experienced ignition within **±5%** of a sensor output of 12.7 V.

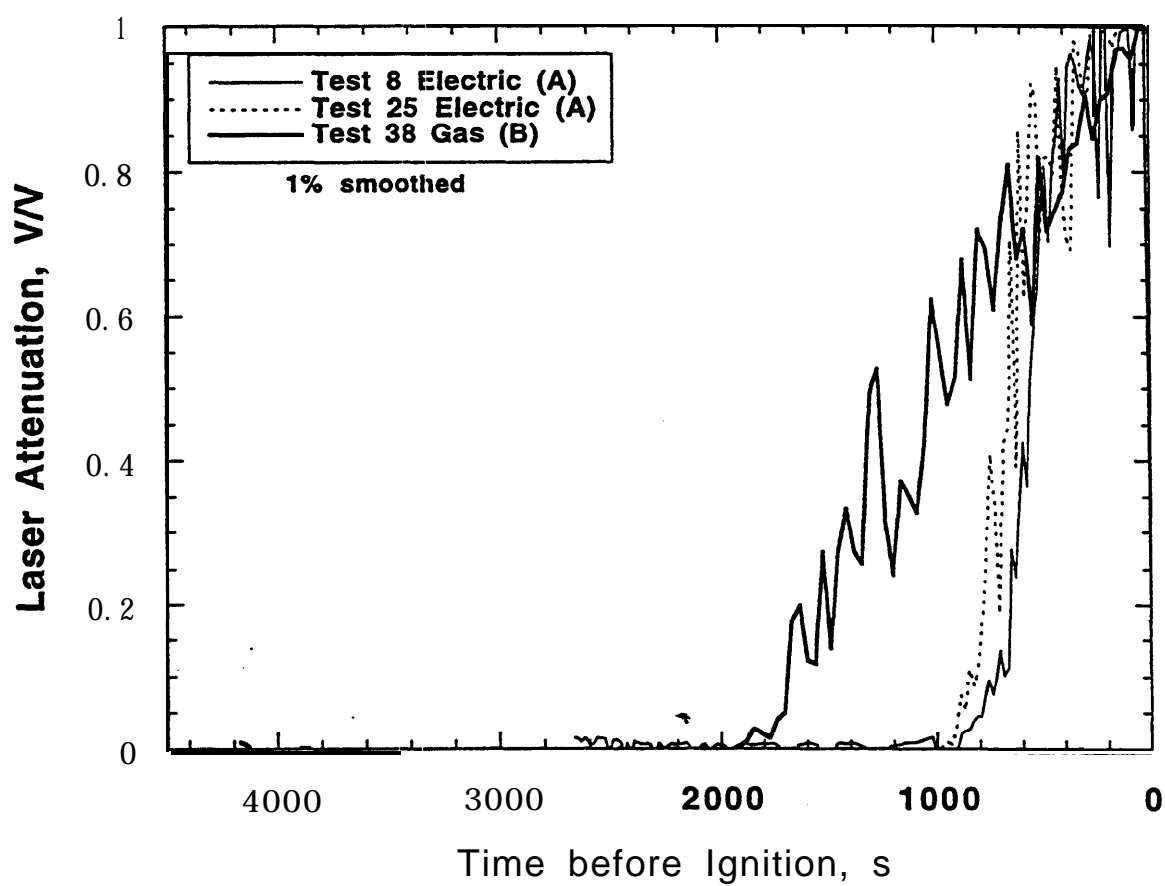
Figure 57. Laser attenuation versus time before ignition for chicken in oil (**normal**→**unattended**) for the electric (A) and gas (**B**) ranges.

Figure 57 shows laser attenuation versus time before ignition for the same chicken test for both electric and gas ranges. While each signal averages approximately 95% attenuation near ignition, the signal for gas cooking rises over 1800 s, and the signal for electric cooking rises over only about 900 s.

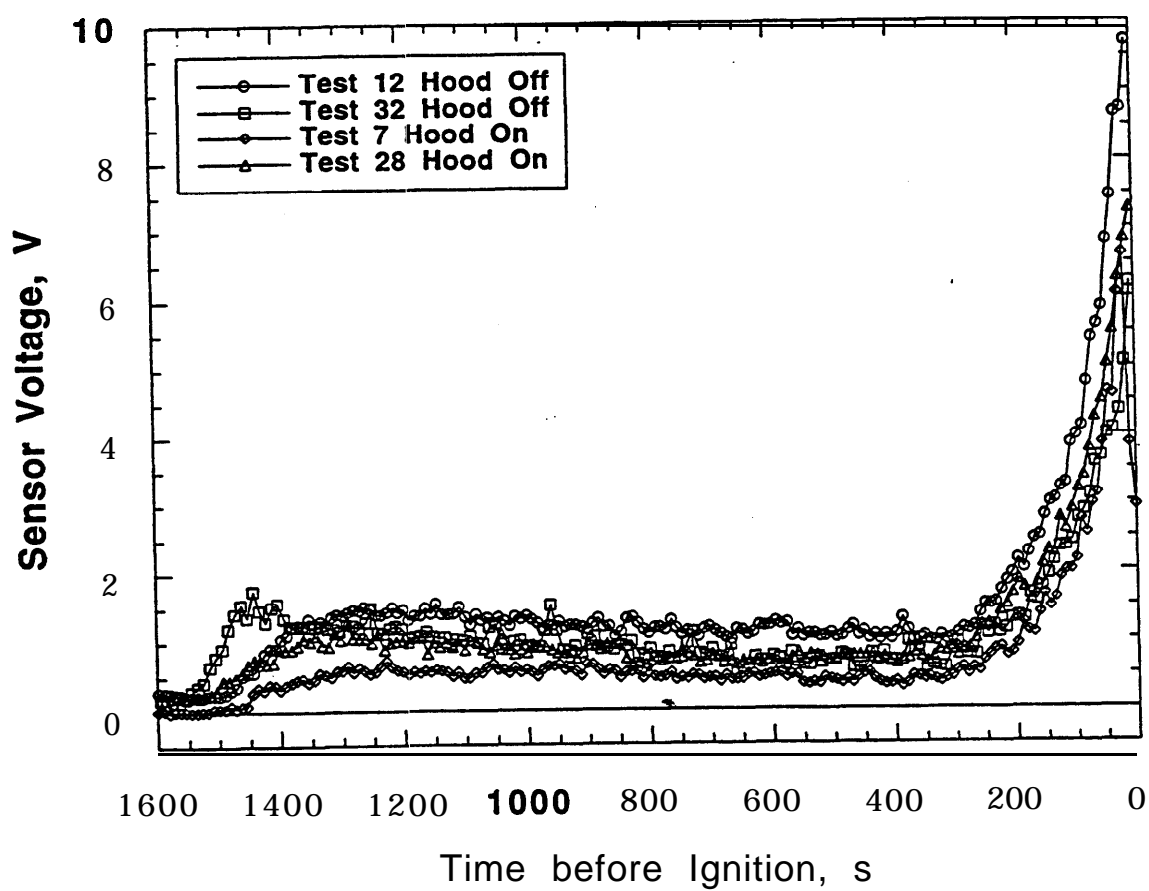
Figure 58. Site 9 general-alcohol sensor response versus time before ignition for water and oil (**normal→unattended**) for the electric (A) range with the hood on and off.

Figure 58 is a plot of the site 9 general-alcohol sensor output versus time before ignition for each of the hood-status comparison tests of water and oil. During the normal-cooking period up to about 500 s before ignition, the two hood-on signals were somewhat lower, probably due to the dilution effect of excess air drawn into the hood. After 1100 s and throughout the rest of the tests, no clear distinction can be made between the two conditions. Variations in the magnitude of signal fluctuations were exhibited by both types of tests.

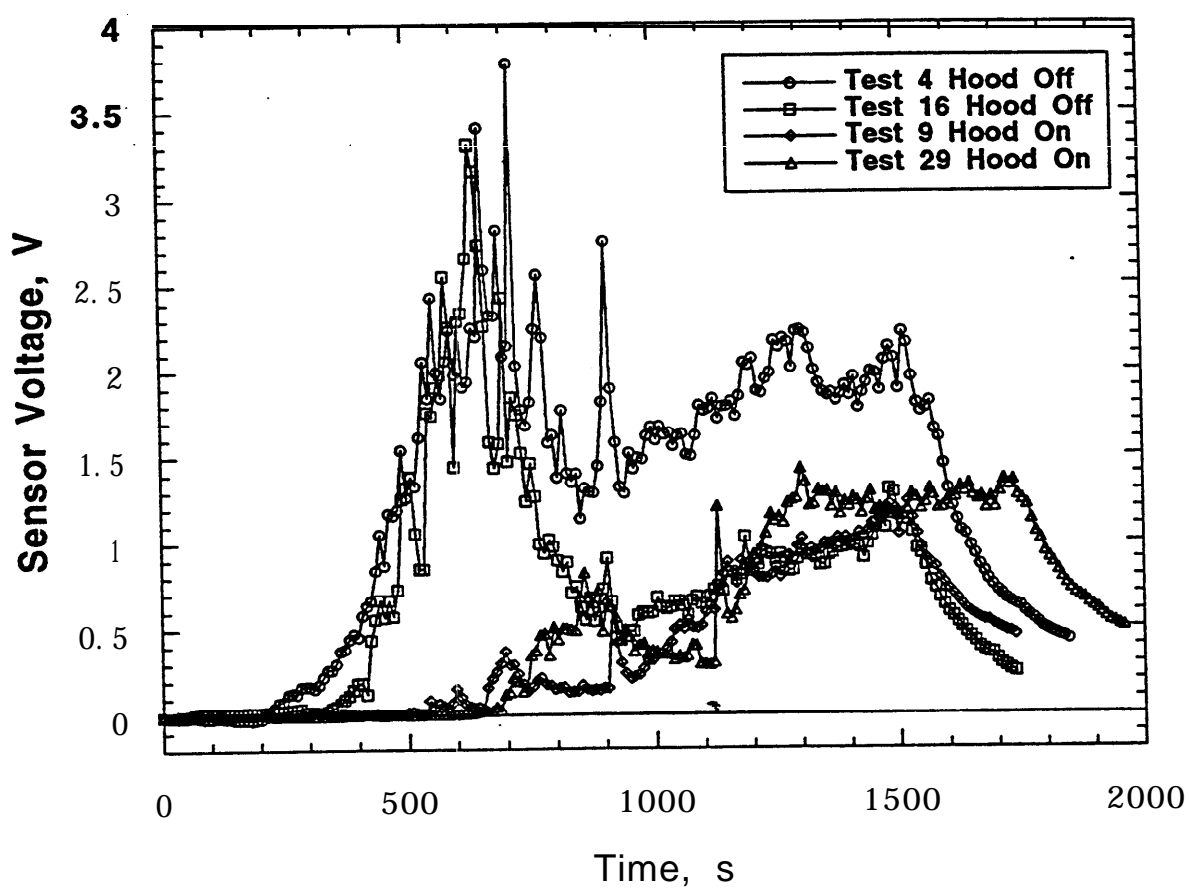
Figure 59. Site 9 general-alcohol sensor response **versus** time for broiled steak (normal) for the electric (A) range with the hood on and off.

Figure 59 is a plot of the site 9 general-alcohol sensor output **versus** time for each of the hood-status comparison tests of broiled steak. The data are plotted versus time and not time before ignition because there was no ignition for the tests. For these tests, it is clear that those with the hood on generally produced a much lower sensor voltage than those with the hood off. After the first 800 s of one of the hood-off tests, the output did decrease to the level of the **hood-on** test outputs. If the maximum signal is deemed most important, then for the broiled steak, a decrease in signal of about 60% was caused by the use of the range hood. Since this is a normal cooking operation, this effect is not detrimental, but would be helpful for condition discrimination if it only **affected** normal cooking and not pre-fire situations.

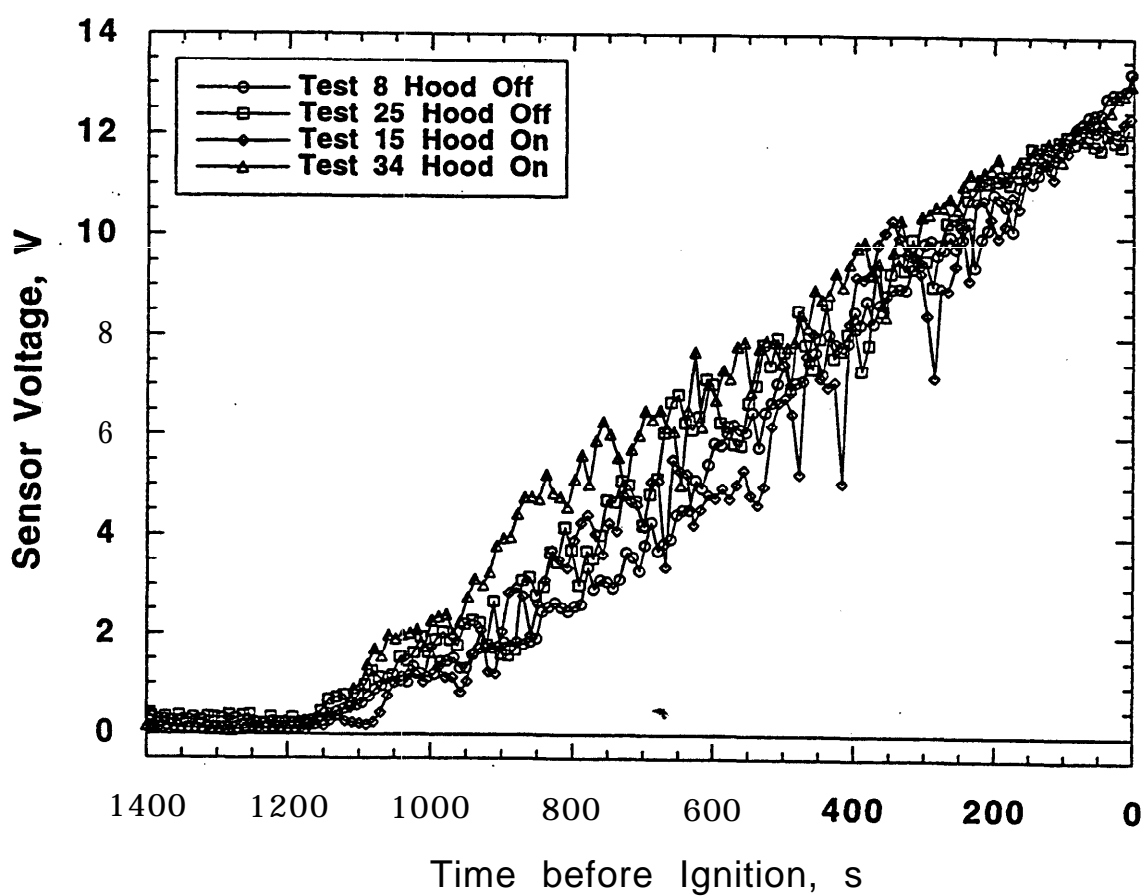
Figure 60. Site 9 general-alcohol sensor response versus time before ignition for chicken (**normal→unattended**) for the electric (A) range with the hood on and off.

Figure 60 is a plot for the same sensor as the previous two plots, but for tests of chicken in oil (normal). For this case, there was no apparent effect on the sensor signal from the hood status. The signals followed the same trends and had the same magnitudes during both the normal-cooking (until 1150 s before ignition) **and** unattended periods of the tests.

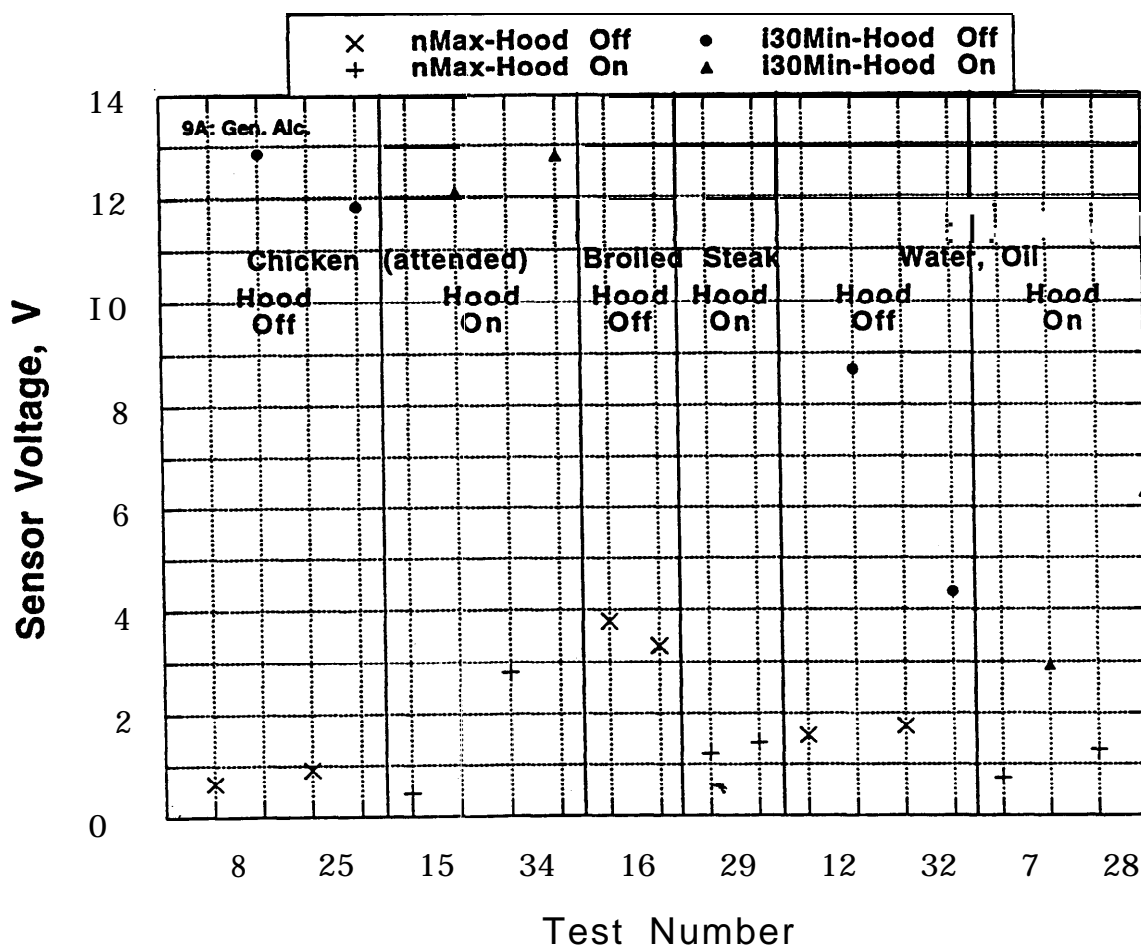
Figure 61. Site 9 general-alcohol sensor responses versus test number for water and oil, broiled steak, and chicken in oil (normal) for the electric (A) range with the hood on and **off**.

Figure 61 is a plot of the maximum normal and minimum 30 s pre-ignition voltages produced by the site 9 general-alcohol sensor for the **water-and-oil**, broiled-steak and **chicken-in-oil** cases that were tested on the electric range with the range hood on and off. This plot shows the differences from test to test as well as between those conducted with the hood on and those with the hood off. A decrease of between 40% and 60% of normal signals due to hood use is apparent for the steak and water-and-oil cases, but not for the chicken case. The effect of the hood status is unclear for the water-and-oil case since the average signal decreased by about 30% for the case with the hood on compared to the hood off, but one hood-on test produced a greater signal than a **hood-off** test. The ignition levels for the chicken tests were **unaffected** by **range-hood** status.

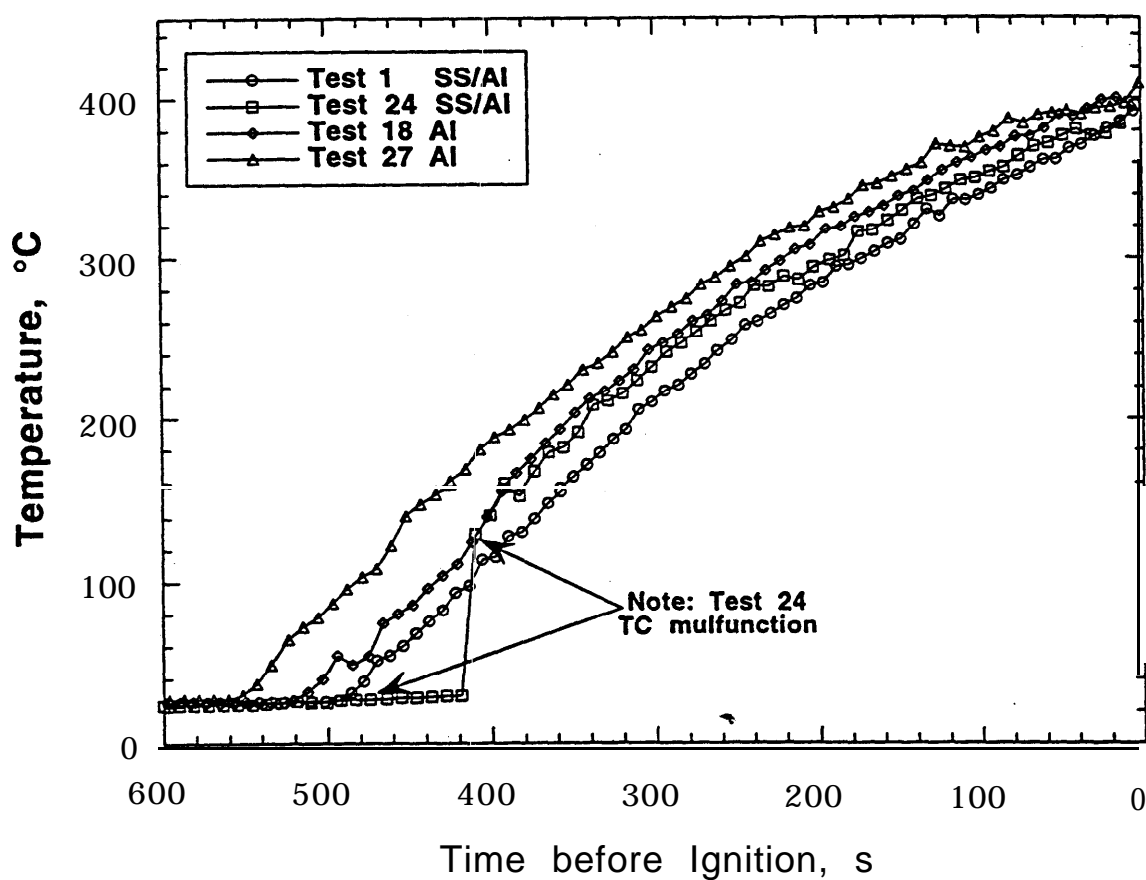
Figure 62. Food temperature versus time before ignition for soybean oil (unattended) on the electric (A) ranges in aluminum and stainless-steel pans.

Figure 62 shows a plot of food temperature versus time before ignition for the soybean-oil tests using each type of pan. Note that the thermocouple in test 24 occasionally malfunctioned. The temperature increases of the stainless-steel-pan tests lagged the increases of the aluminum-pan tests by about 50 s. Apart from the timing difference, the slopes and magnitudes of the results from the two types of tests were nearly identical. The ignition times for the aluminum tests averaged 18 s shorter, yet it is not clear whether this is a pattern because one of the steel tests had an earlier ignition time than one of the aluminum tests. Figure 63 shows a plot of the site 9 general-alcohol sensor response versus time before ignition for the same tests. No clear difference is apparent between the pairs of tests.

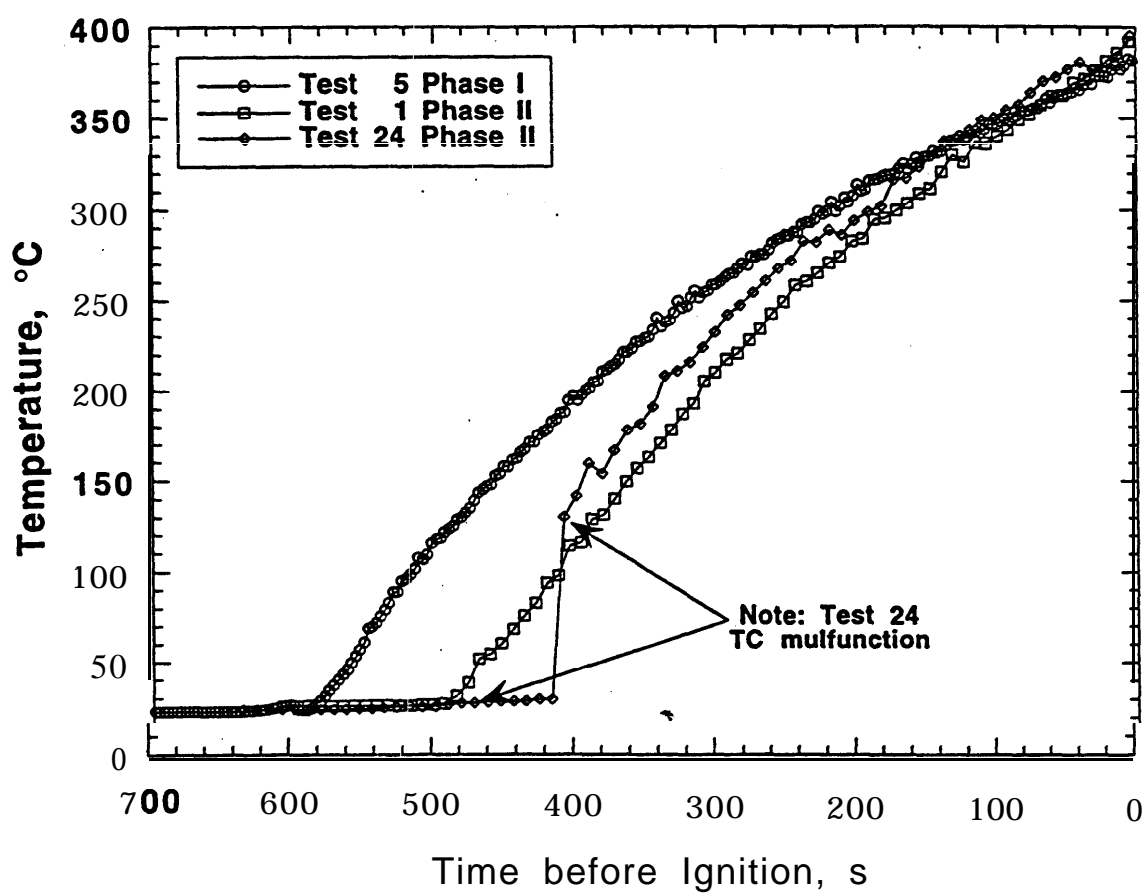
Figure 64. Food temperature versus time before ignition for soybean oil (unattended) on the electric (A) range: for Phase I and Phase II.

Figure 64 shows a plot of food temperature versus time before ignition for soybean-oil tests conducted on the "A" electric range for both series of experiments. The tests have similarly shaped temperature-time **curves**, but the Phase II tests are somewhat compressed in time. The final difference in time to ignition is about 100 s with the Phase I test requiring 15% longer to reach ignition than the Phase II tests. The temperature magnitudes are the same at ignition so there would be no impact of the **differences** in heating rate on pre-fue detection based on temperature.

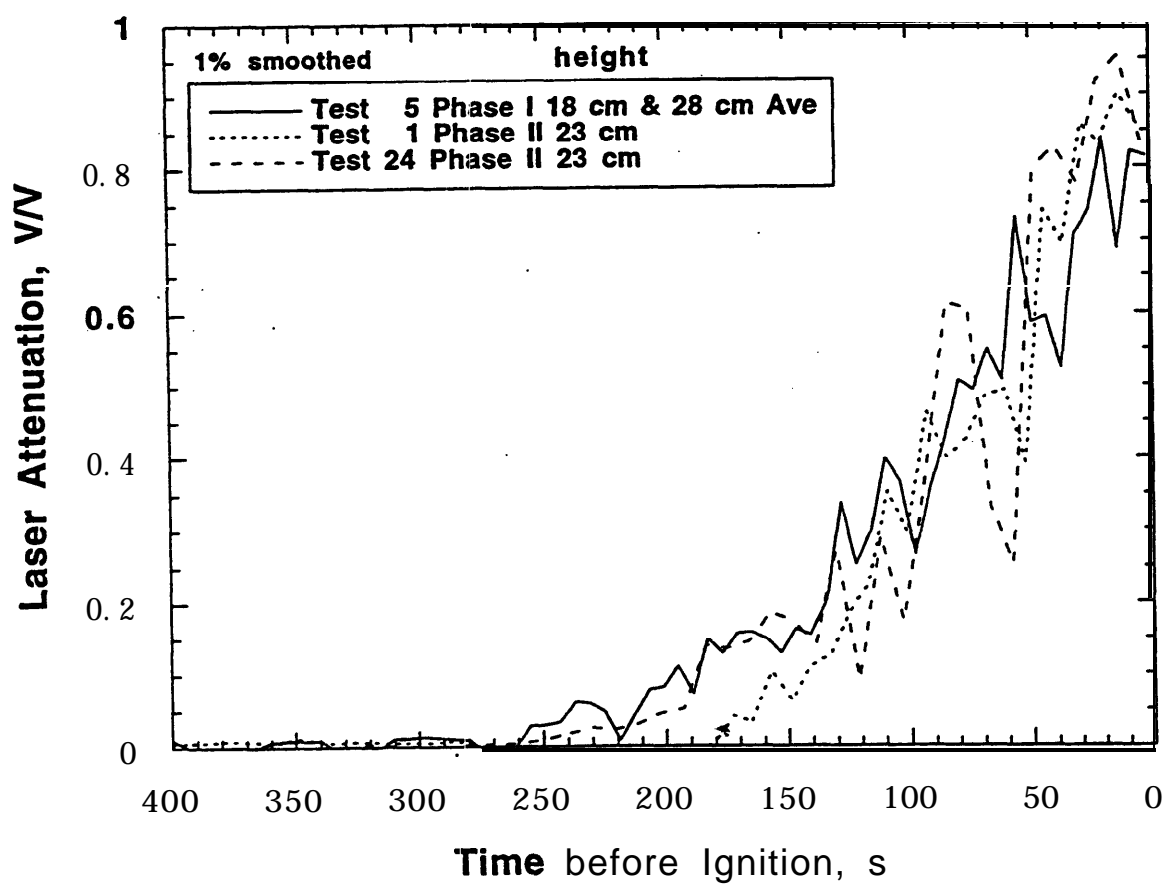
Figure 65. Laser attenuation versus time before ignition for soybean oil (unattended) on the electric (A) range for Phase I and Phase II.

Figure 65 shows laser-attenuation signal versus time before ignition for the same oil tests from both experimental series. The heights of the laser beams were different for each phase so the signals cannot be directly compared. The Phase I testing resulted in data for two heights, and the beam height during Phase II was halfway between these so the average of the Phase I results should be roughly comparable to the Phase II results with the assumption of a linear correlation of attenuation with height. Except for the longer time required for the Phase I signals to increase relative to the Phase II signals, the trends and magnitudes of the tests are similar. Again, the differences here are in heating rate only and are inconsequential to feasibility of detection based on exceeding thresholds of monitored conditions.

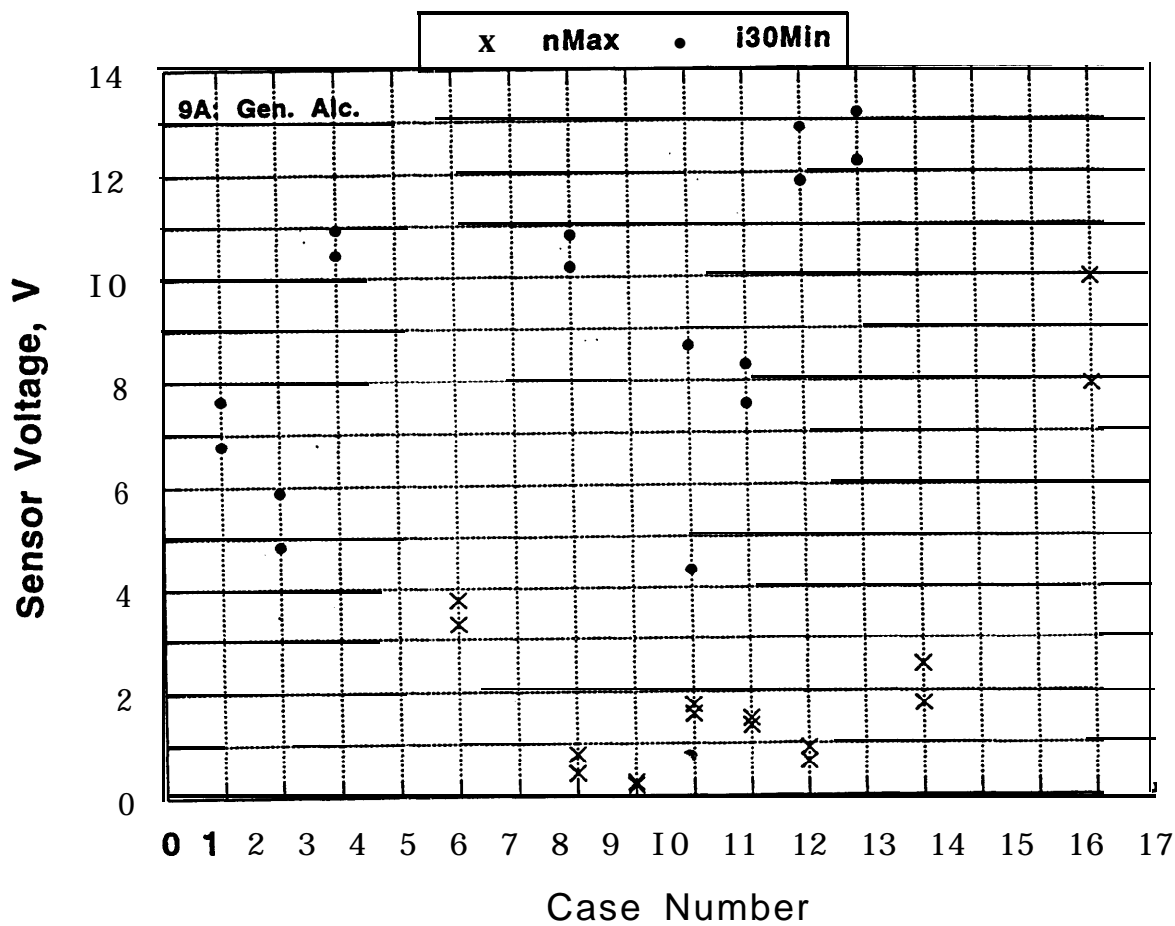
Figure 66. Site 9 general-alcohol sensor maximum normal and minimum ignition output 30 s before ignition versus **cooking** case number for **tests** using the electric (A) range and inactive hood.

Reproducibility within the Phase II results has already been shown in some plots such as Figures 55 and 56. In this section, the maximum normal and minimum 30 s preignition levels of signals needed for distinguishing the conditions are inspected to establish reproducibility. In Figure 66, the site 9 **general-alcohol sensor** responses are plotted versus cooking case number for those tests performed on electric range A with the hood off. Repeated tests are plotted together for each type of case. A typical variation of ignition levels is about 1 V between repeated tests, as observed for cases **1-3, 7, and 10-12**. Each pair's variation is between 5% and 20%. A larger difference is seen in case 9 (4 V or 50%). Normal level variations were on the order of 1 V or less except for the self-cleaning oven, case 16 (2 V or 25%).

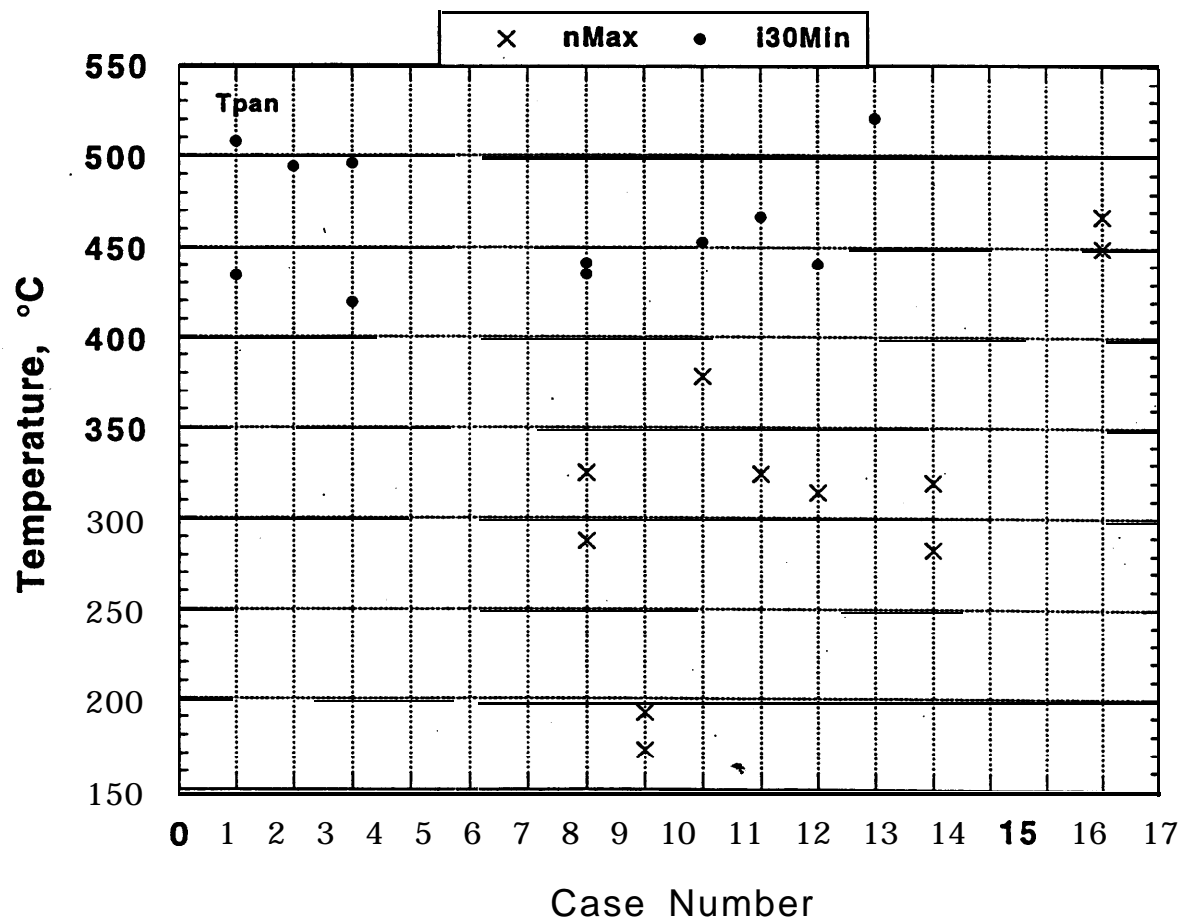
Figure 67. Pan-bottom temperature maximum normal and minimum ignition output 30 s before ignition versus; cooking case number for tests using the electric (A) range and inactive hood.

Figure 67 shows the **pan-temperature** maxima and 30 s minima **versus** case number. For the cases with two sets of data, pre-fire minimum variations were 10°C (20°F) for case 7 and

80 °C (140 °F) for cases 1 and 3. The normal-condition pairs varied by 25 °C (45 °F) to 40 °C (70 °F) for cases 7, 8, 13, and 16.

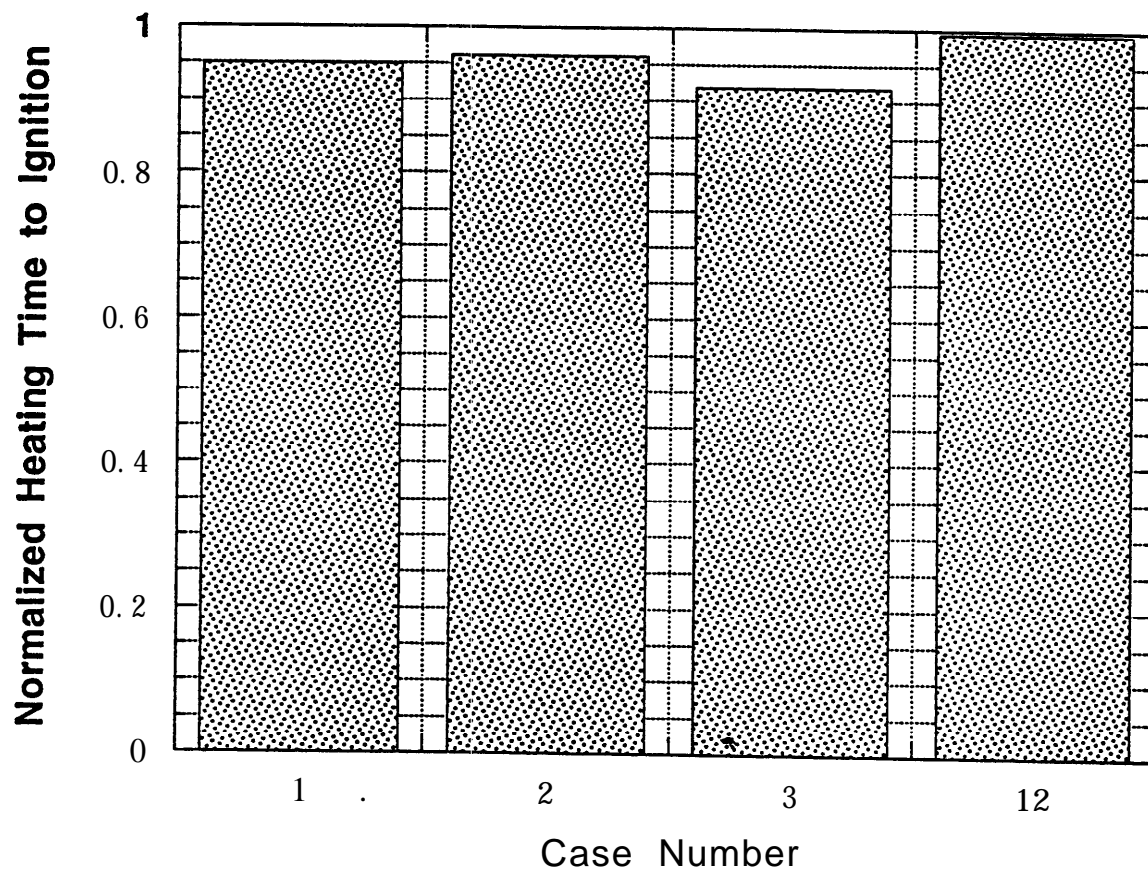
Figure 68. Heating time to ignition versus cooking case number for tests using electric (A) range and inactive hood.

Figure 68 shows the heating times to ignition for replicate tests of four cases of unattended **cooking**. The times have been normalized by the longer ignition time of the two repeated tests. The variations range from 0.5% for case 12 to 8% for case 3 with an average of about 5%.
